Ref DA: D/2023/299, 181 St Johns Road GLEBE NSW 2037  
Attention: Mr Christopher Ashworth

The development application is for the demolition of a single storey free-standing mid-Victorian house (Figure 1) which is a Contributory item in the Hereford Forest Lodge Heritage Conservation Area, its replacement by a pair of conjoined three storey houses (Figure 2) and to carry out a subdivision.

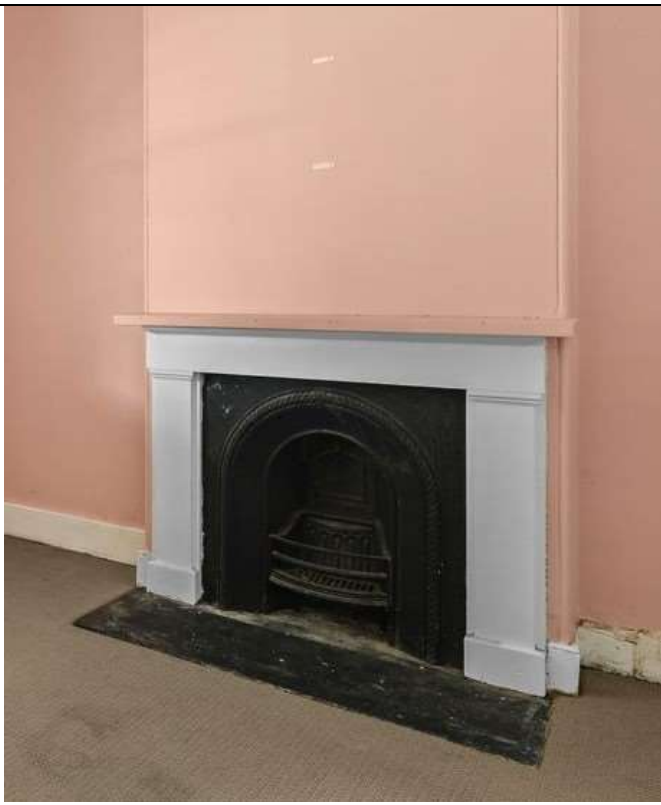
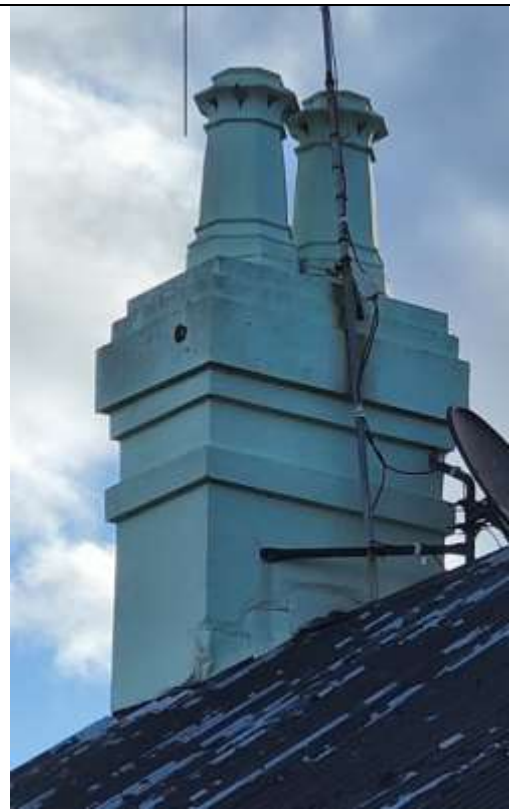
Fig 6, 7: the chimney piece, staff moulds, chimney and chimney pots and palisade fence (see Figure 9) are typical of a house dating from the middle of the 19<sup>th</sup> century

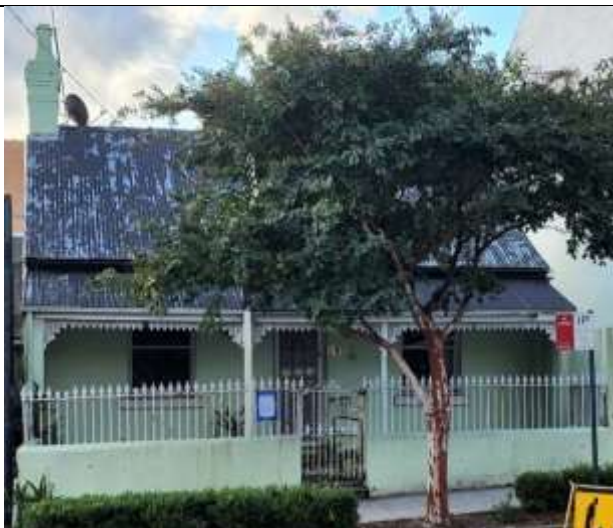
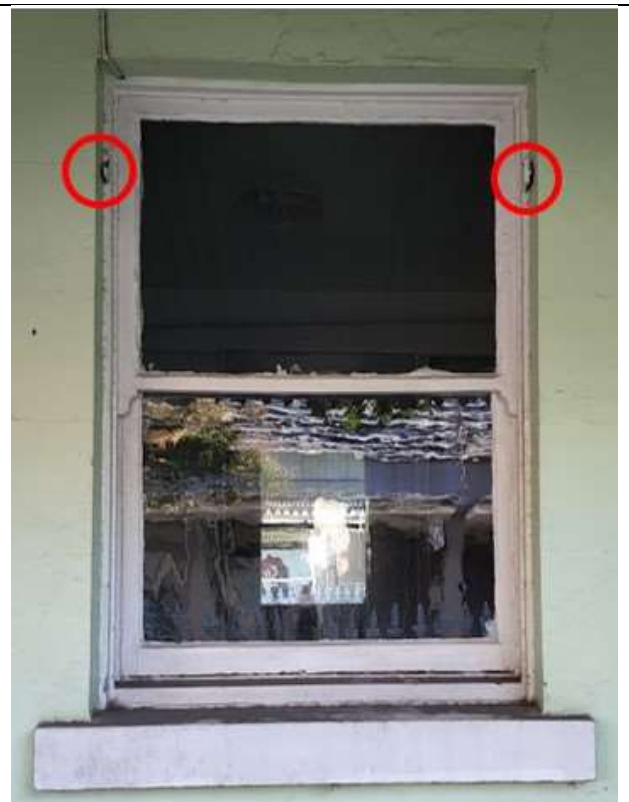
Figure 10 The sash windows on the front elevation originally had shutters. Parts of the shutter hinges survive as do the timber linings the hinges were attached to.

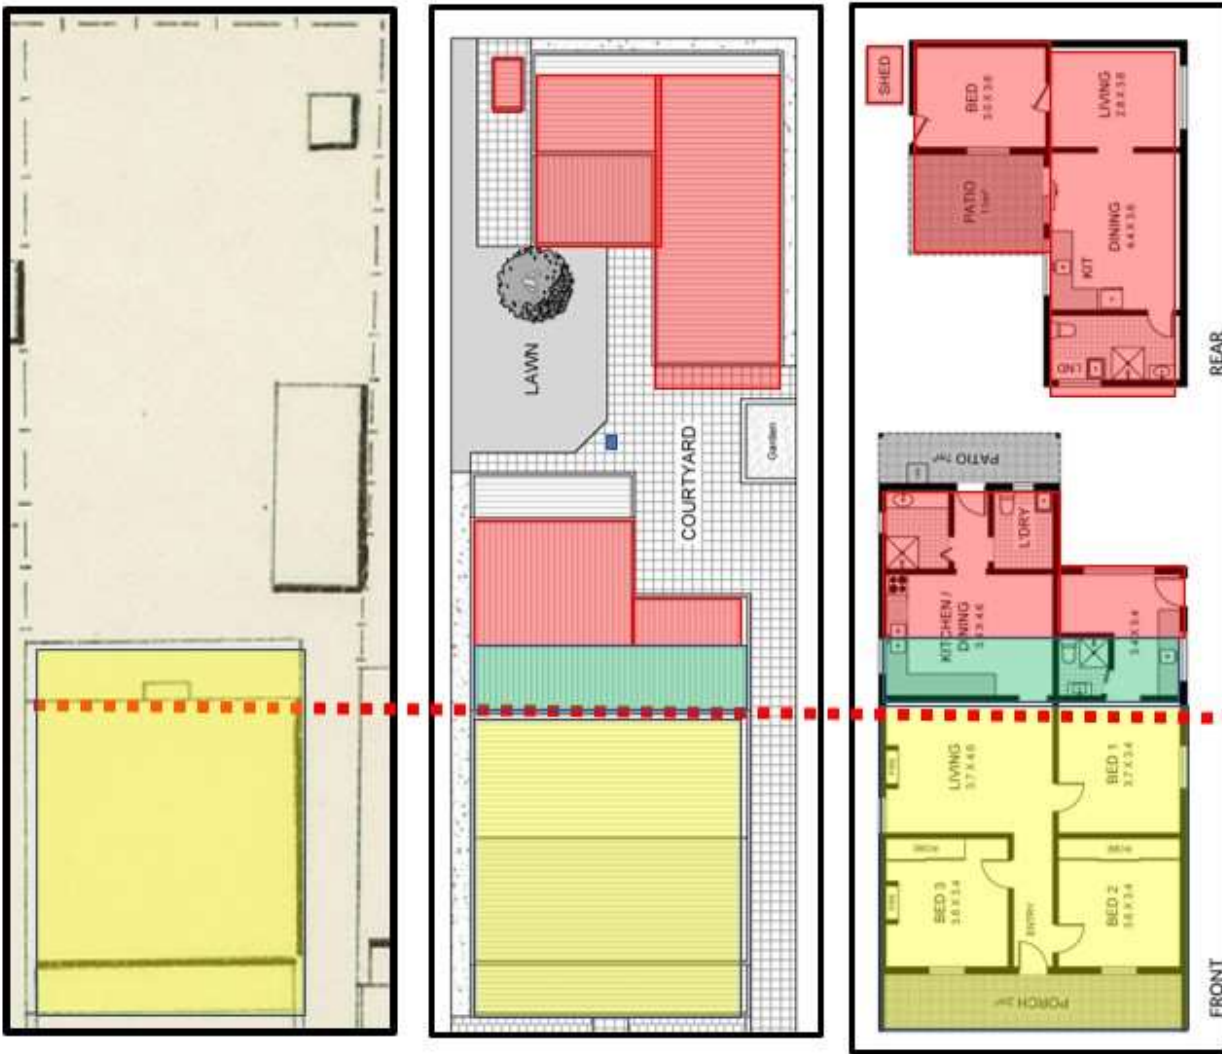
Figure 17 The house as recorded in 1889 had a verandah or shallow skillion on the east elevation. This has been either demolished or altered a number of times. The division between the main house and the skillion is shown by the dotted line. The front verandah, main elevation including its fenestration, much of the joinery and the original floorplan of the main house survive. The rear skillion appears to be of little or no significance.

The elevations, form, chimney and plan of the original house are intact. The front elevation to St Johns Road with its original sash windows, verandah and palisade fence is highly intact as is the south west front room with its chimneypiece. The rear building is of no significance and the skillion at the rear of the original house is of little or no significance – see Figs 14, 15, 16, 17, 18, 19 & 20.

The skillion attached to the northern side of the house was built in stages. Whilst it may contain some early fabric it does not appear to be intact in terms of room volumes, fenestration and finishes. A proper heritage impact statement should have been part of the development application in accordance with Section 3.9.1 of the General Provisions of the 2012 City of Sydney Development Control Plan, particularly sections (3), (4) (a), (b), (c) and (d). The application is completely deficient in its analysis of the house, its evolution, its significance and its condition. Subject to a proper assessment it would appear acceptable to remove the skillion wing and replace it with a new wing.

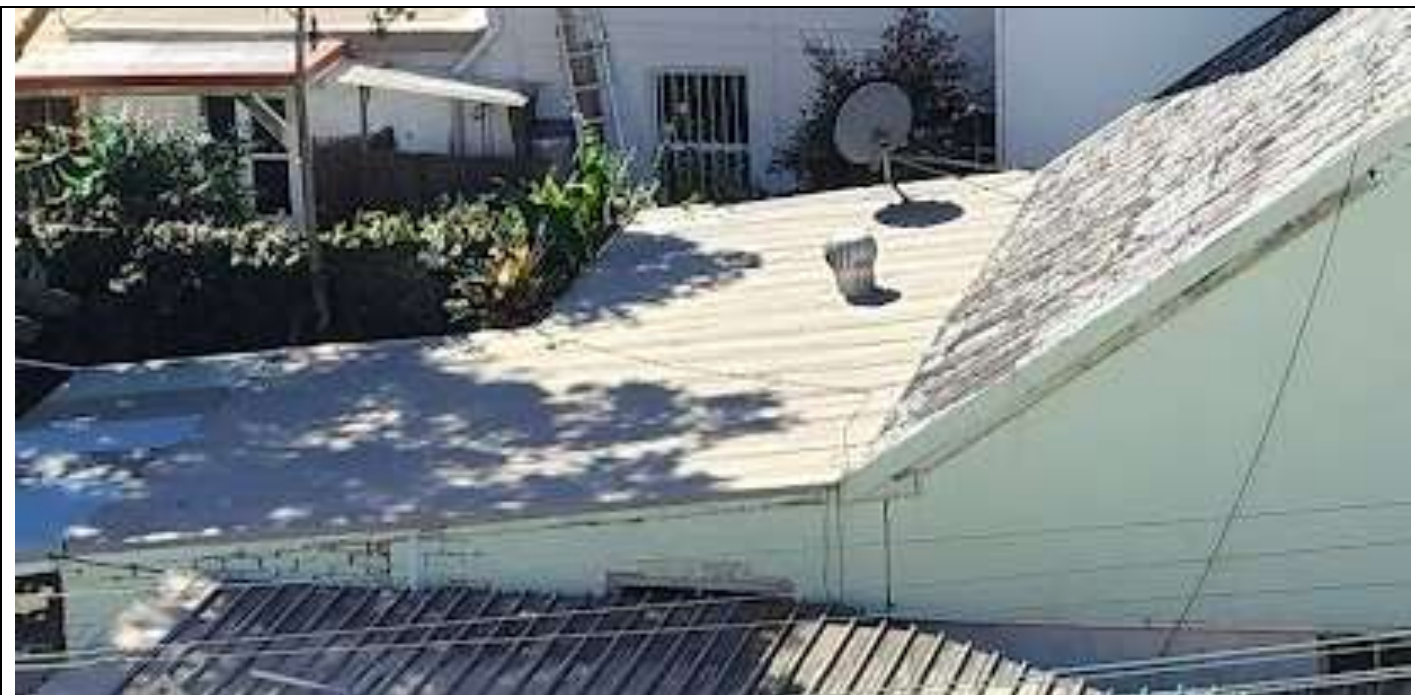
Figure 18 The western elevation of the rear skillion

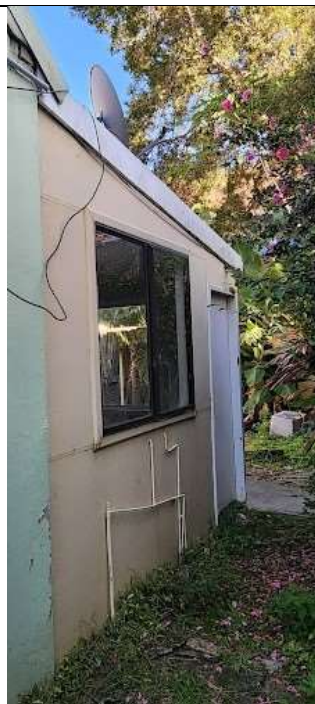
Figure 19 The eastern elevation of the rear skillion

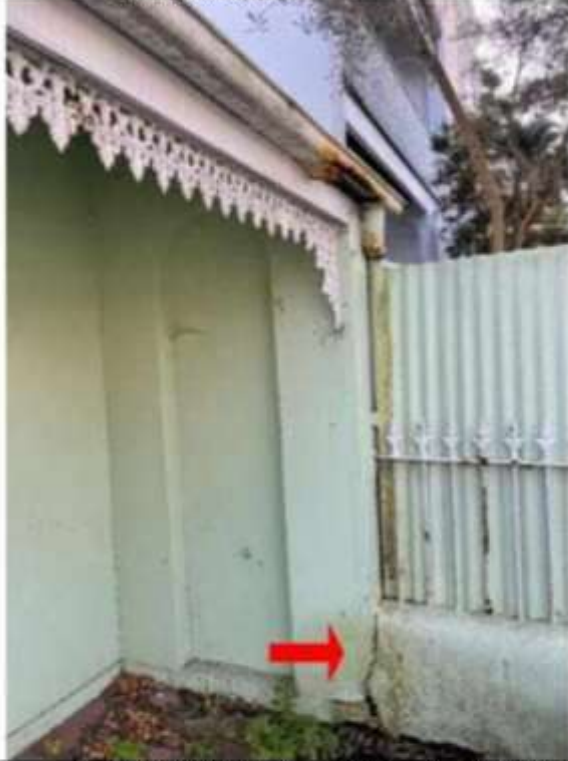
Figure 22 Structural Report, attributes the crack between the palisade fence kerb and the front of the house to subsidence of the rear part of the house

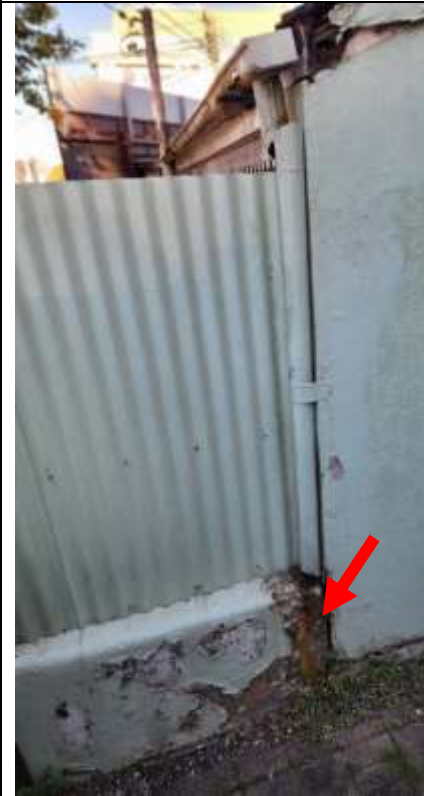
Figure 23 The crack can be attributed to a leaking down pipe. It should be noted that the palisade wall fence is not rotating but remains in the vertical. The problem could be ameliorated by fixing the down pipe and removing the paving next to the wall

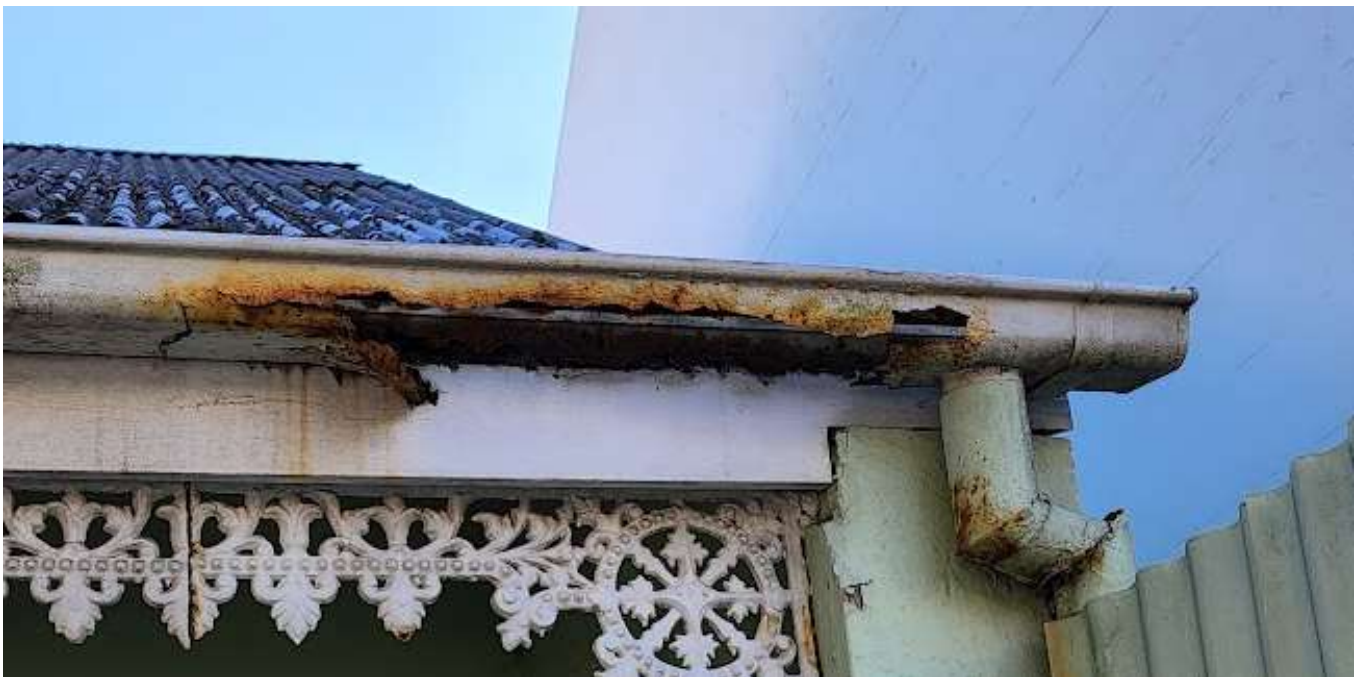
Figure 23a The guttering is in poor condition

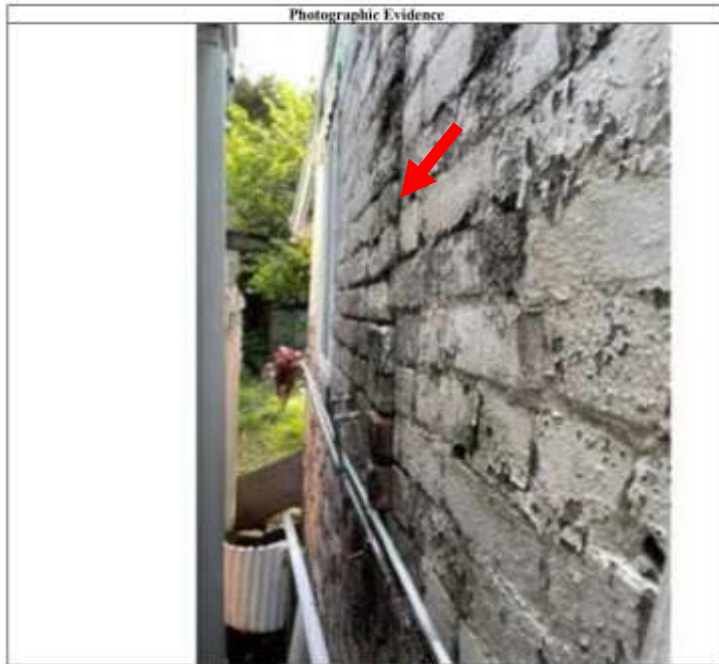
Figure 24 The structural report attributes the crack in the brick wall on the western wall of the skillion to subsidence when it relates primarily to the method of construction, see Fig 25

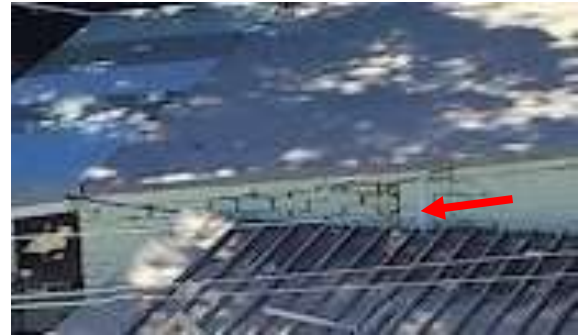
Figure 25 The skillion wall on the western side of the house was built in two stages. The brickwork of the northern end was not tied into the earlier wall. The crack relates to the method of construction rather than subsidence

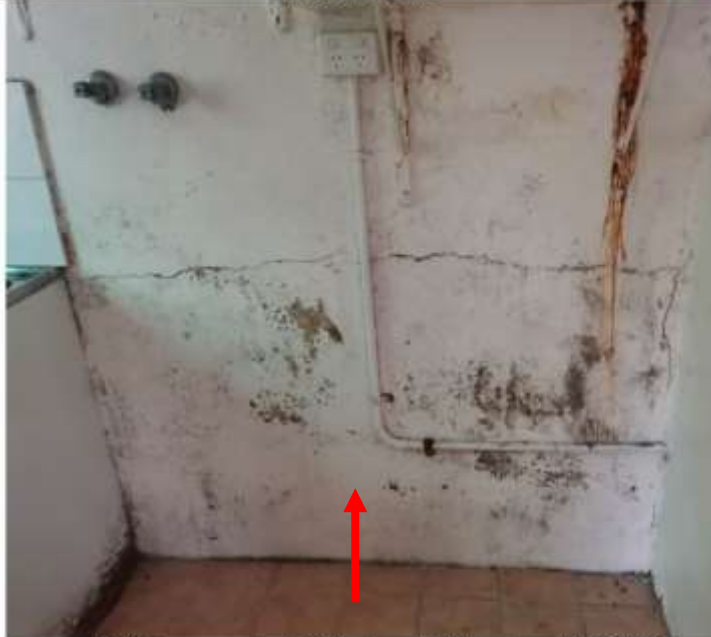
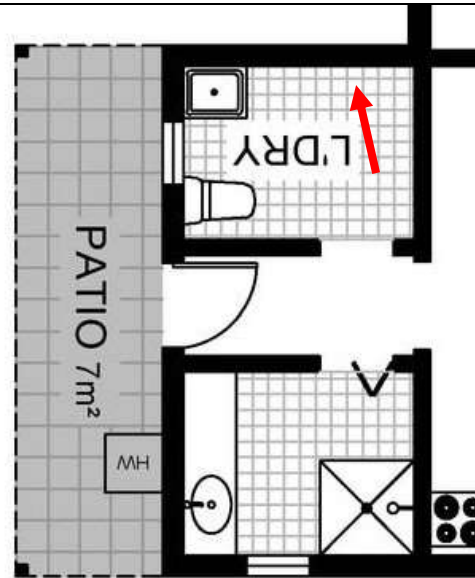
The report does not identify the room illustrated but it appears to be the laundry which is located in the stage 2 skillion addition at the rear the main house (see the plan at Fig 16). The damp problems are being caused by the concrete slab, exacerbated by the leaking down pipes. The floors of the skillion additions appear to all be of concrete slab construction.

Figure 26 Rising damp

The original house appears to be solidly built and structurally sound. The primary problems relate to rising damp caused by leaking gutters, failing downpipes, the slab floor of the rear skillion, the hard paving which abuts the house and the raising of the level of the front garden. All these problems could be rectified, they do not justify demolition of the house.

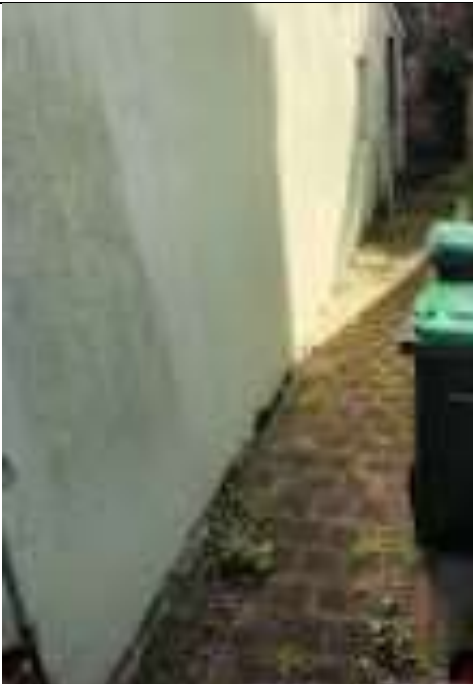
The original house is surrounded by hard paving on the eastern side (see Fig 27 ), as well as the concrete slab in the northern skillion. In addition the ground level of the front garden has been raised (Fig 28). These, along with the leaking downpipes are the principal cause of the damp issues.

Figure 27 Hard paving has been constructed right up to the eastern wall of the house

- IV. The application argues that the house is structurally unsound and must be demolished. No systematic evidence and analysis is presented to support this assertion. The original house appears to be structurally sound. Issues with damp could be rectified by fixing the gutters and downpipes, removing the hard paving abutting the house and removing the slab in the later skillion at the rear of the house.

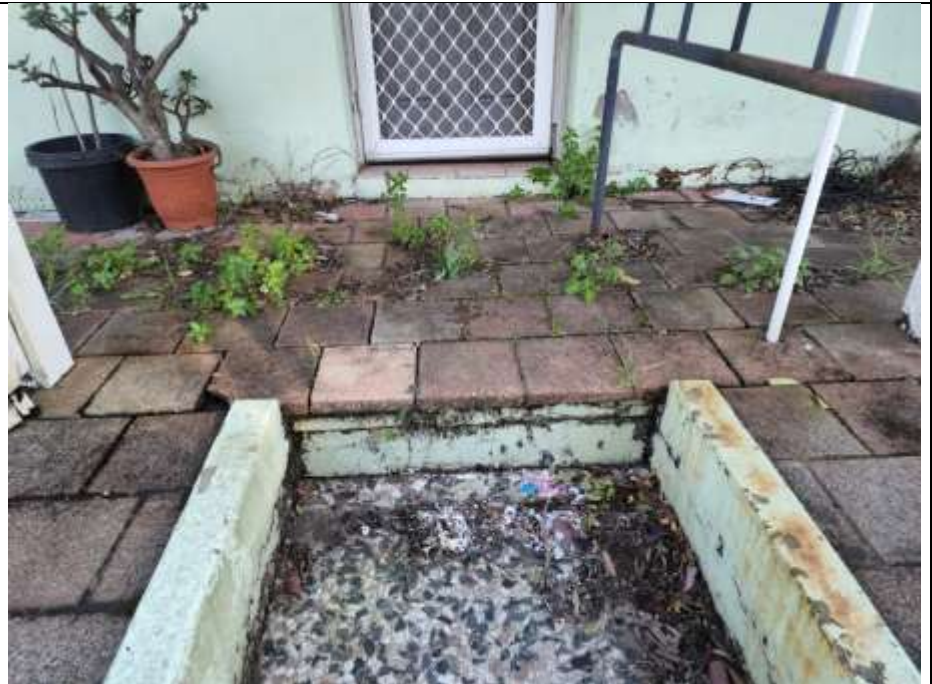
Figure 28 The level of the front garden has been raised to the height of the veranda. This with leaking gutters and downpipes is likely to exacerbate damp.
