Re: Site address: 20 & 22 Forest Street , FOREST LODGE NSW 2037, 13 & 15 Ross Street , FOREST LODGE NSW 2037 Appeal to the Land & Environment Court: RE-NOTIFICATION (COURT APPEAL)

This submission focuses on the proposed change to the Forest Street elevation of the DA. In our view demolition of the houses at 20 and 22 Forest Street is not justified and the changes to the design of the Forest Street elevation do not alter this.

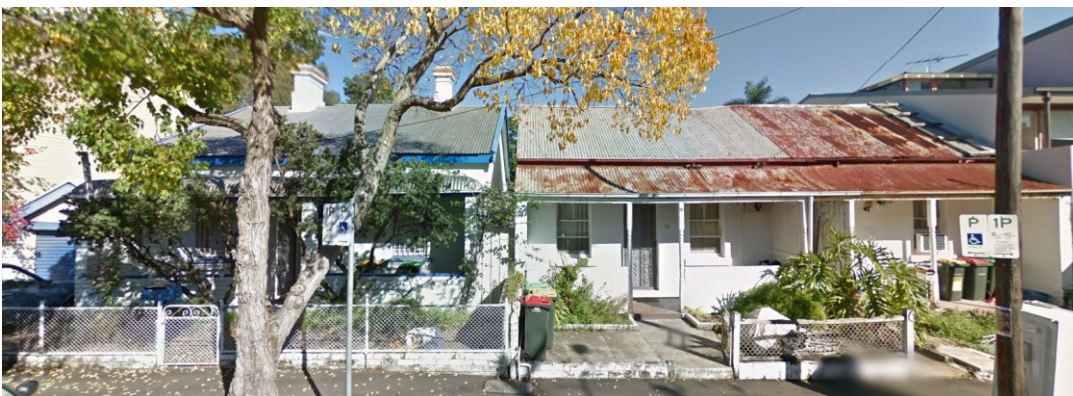
The fact that there are only a small number of these one storey mid-19th century workers cottages in the precinct; Lodge Street has two; Forest Street has three; St Johns Road two and that number 18, 20 and 22 Forest Street (the three Forest Street ones) are the only grouping of the typology, reinforces the importance of 20 and 22 Forest Street to the Heritage Conservation Area and the need to keep them.

Figure 1 Numbers 20 and 22 along with 18 Forest Street comprise a group of three single storey early vernacular houses

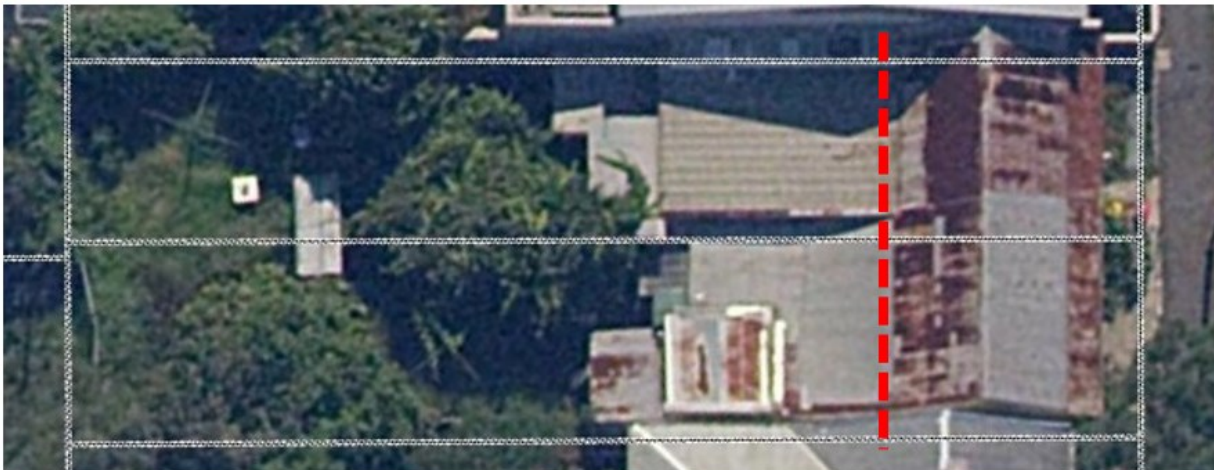
The cottages are built close to the front of the block (see Figure 2 below). The skillions to the left of the dotted line in Figure 2 are less significant than the main section of the houses under the gabled roof.

Figure 2 Figure 20 The principal parts of the cottages are located at the front of the blocks, to the right of the dotted line

As set out in the analysis in Section 5 above the exceptional circumstances to justify the demolition of these contributory buildings have not been established. Accordingly the plans should be modified to retain the principal sections of the houses. The Society has no objection to the demolition of the skillions at the rear of the properties (see Fig 2 above).

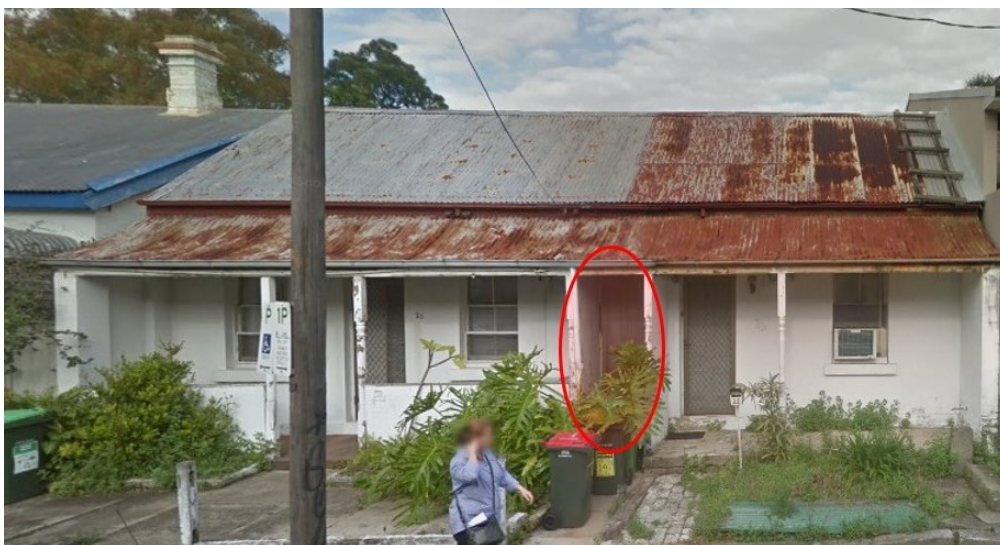
The dwellings have direct access from the street to the garden via the former night soil alley (see Figure 3 below). This provides considerable flexibility allowing for the pair of houses to be retained while providing the potential to develop additional density in the garden behind.

Figure 3 The door circled in red leads into a passage which was separate from the two dwellings and led to the backyard.

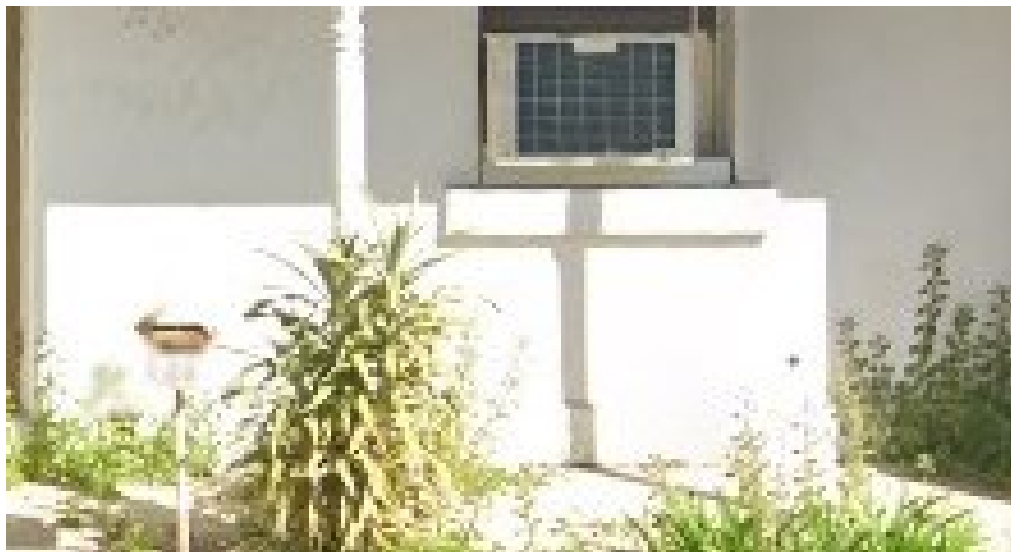
Our submission of 5 July 2023 included photographic evidence which establishes that the loss of render and misalignment of some of the bricks occurred between 2021 and 2023, see images 4, 5, 6 and 7 below.

Figure 4 Number 22 Forest Street, Feb 2021 (Google street view)

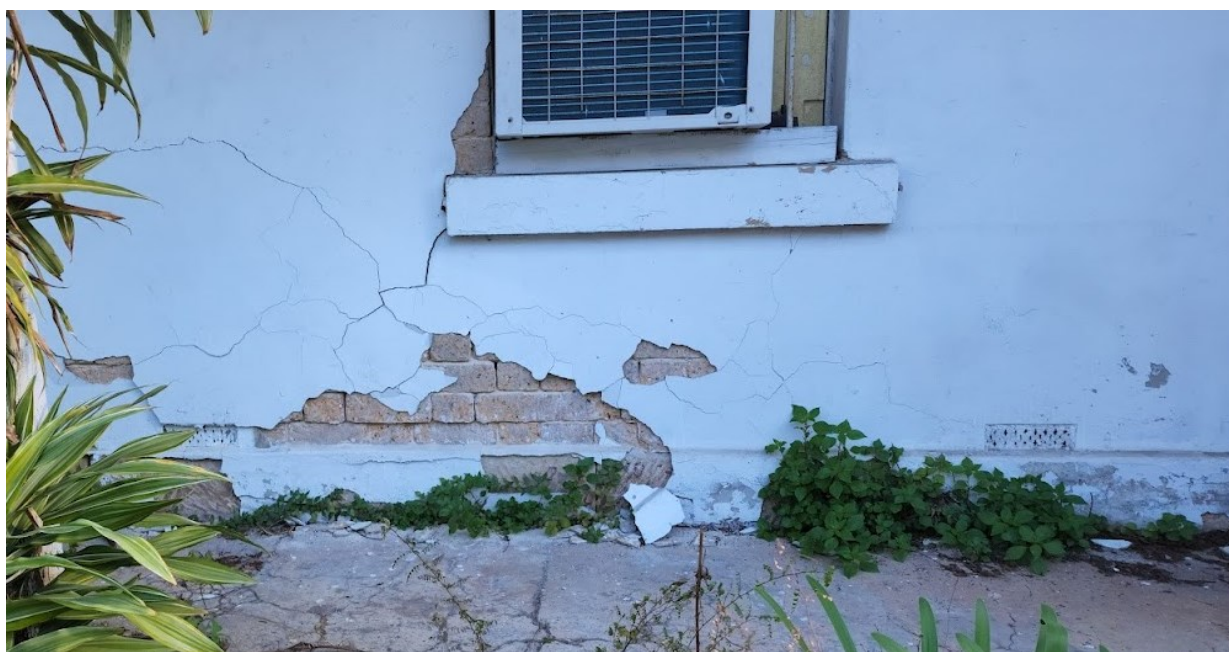
Figure 5 Number 22 Forest Street, June 2023 showing cracking which appears to have been caused by the impact of a heavy object

The houses were built in the 1870s. The loss of internal and external plaster between 2021 and 2023 is not likely to be the result of movement in the footings which have supported the house for 150 years.

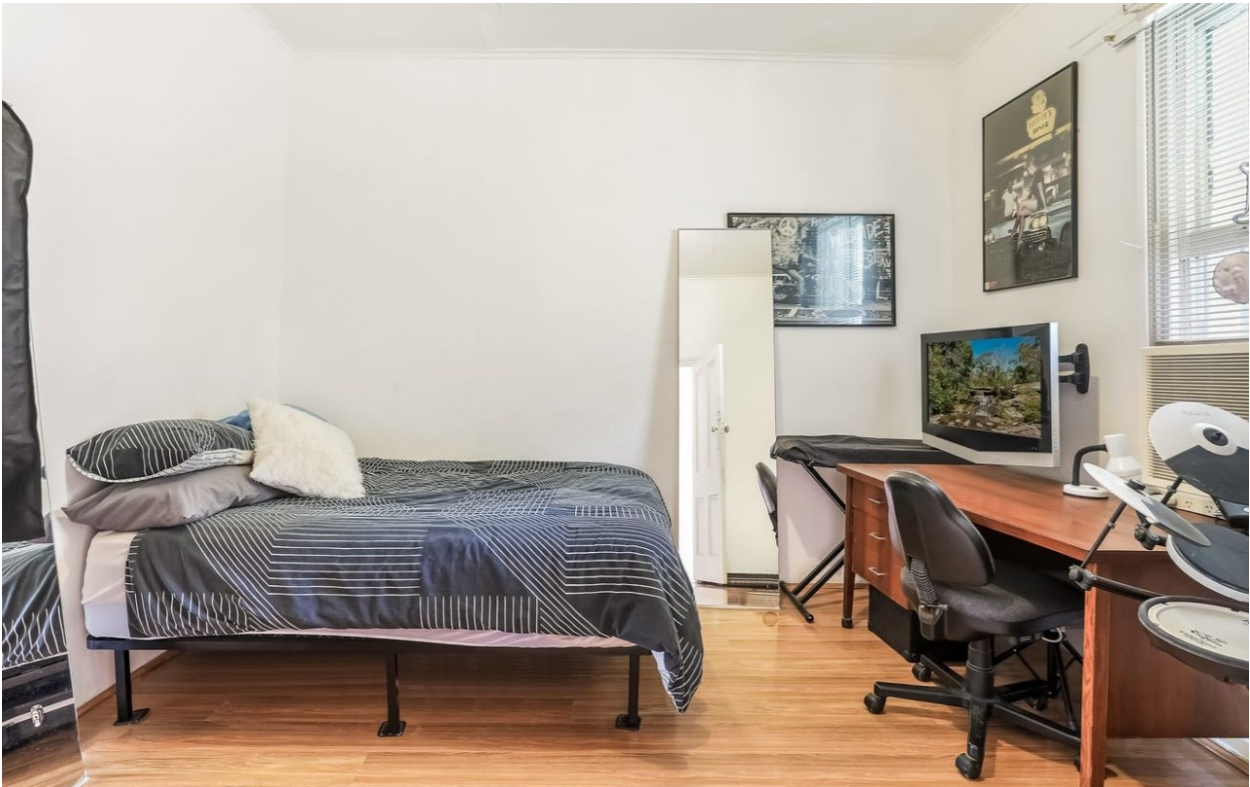
Figure 6 Interior view in 2021, the window in the north eastern wall can be seen on the right (realestate.com), and Fig 7 below.

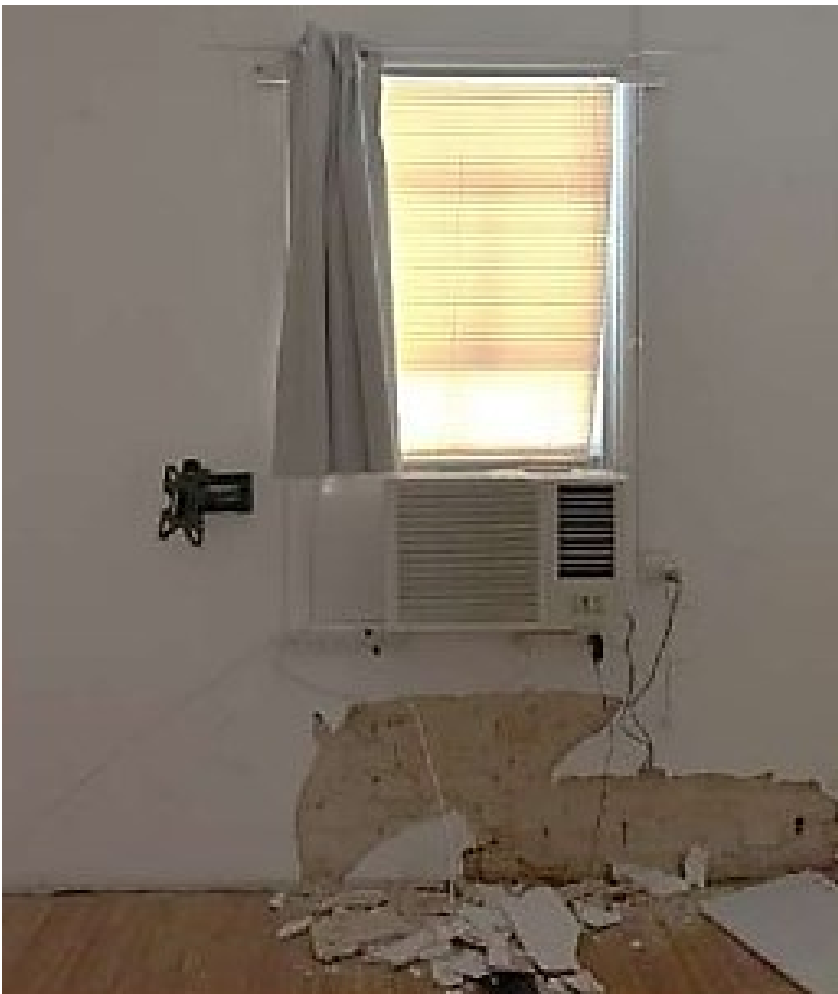
Figure 7 Inside view of the north eastern wall of number 22, Weir Phillips Heritage Impact Statement 20—22 Forest Street Forest Lodge , March 2023.. The wall beneath the window appears to have been impacted by a heavy force

The north eastern brick wall, in fact sits on a stone plinth not, as the structural report states, brick footings. The wall appears well founded. The cracking in the wall does not appear to have been caused by movement of the footing as a result of reactive ground s but appears to result from the impact of a heavy object hitting the wall from inside the house.

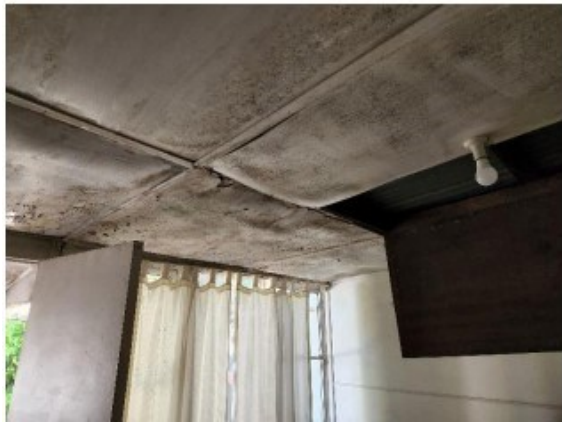
The engineering report includes a number of unsubstantiated claims, for example it assumes that all the roofing timbers are rotten while admitting they have not been examined. The assumption is based on water damage to the rear skillion of number 20 Forest Street (see figure 8)

Figure 8 This image in the Structural Report of a water damaged ceiling is in the skillion of number 20 not the main house

Overall the ceilings are in better order than the report claims. The damage to the ceiling illustrated at Fig 2 of the Structural Report (re Figure 8 in this submission) is in the rear skillion of number 20 not in the main section of the building under the pitched roof.

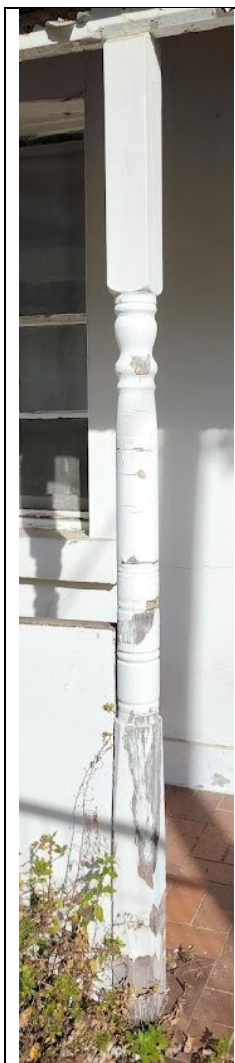
Figure 98 One of the verandah columns

It is claimed that the external columns have deteriorated at the base and are in an unstable condition.

The turned hardwood columns are in good order. There is some minor deterioration at the bases. This is not unusual in historic buildings and can be easily rectified. The columns have lasted 150 years. The timber is of better quality and longer lasting than what is available today.

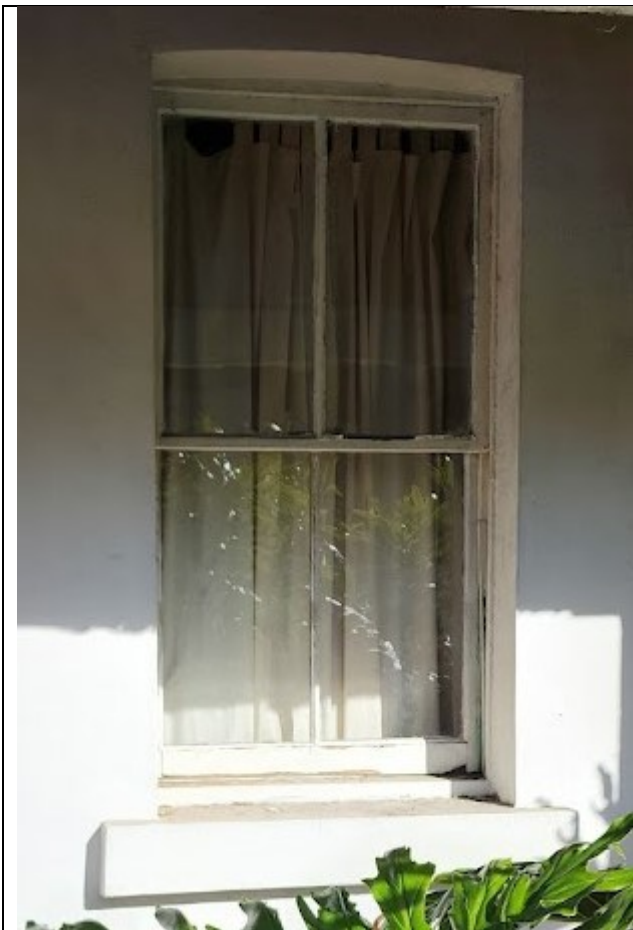
Figure 11 One of the three sash windows on the eastern elevation

The sash windows on the eastern elevation and their frames appear to be in reasonable condition as are the pair of panelled front doors and their frames and linings.

The three sash windows and pair of front doors are all original elements

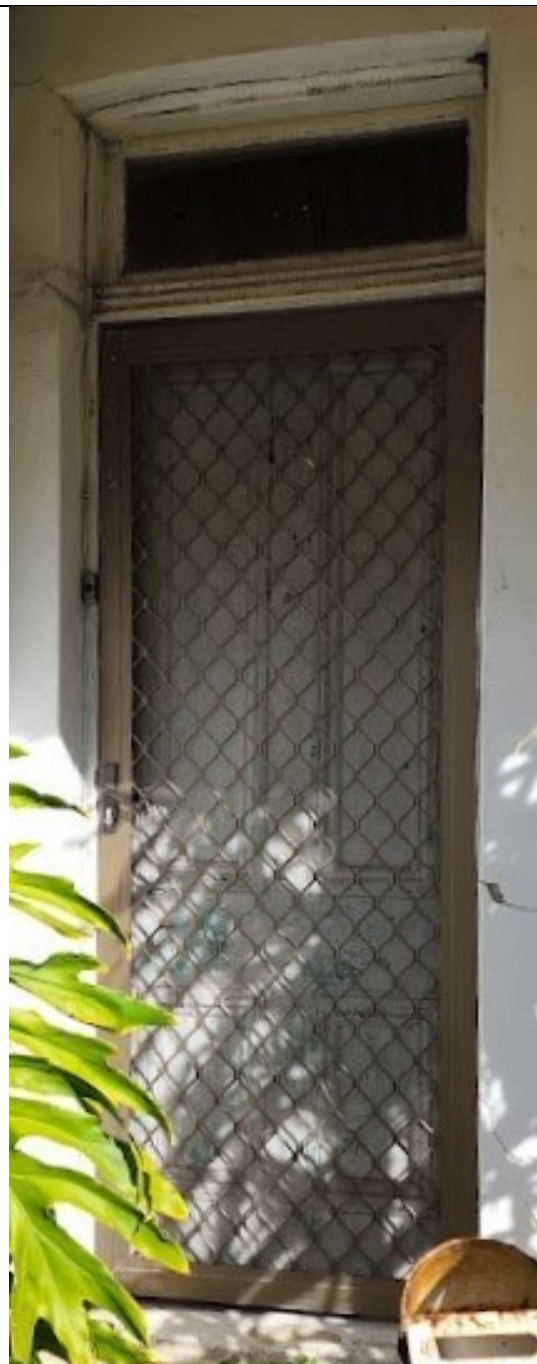
Figure 12 The front door of number 22. Number 20 has a matching panelled door
