Re: DD/2024/509 1-7 Bellevue Street, Glebe

The Glebe Society makes the recommendations set out below in respect of the application.

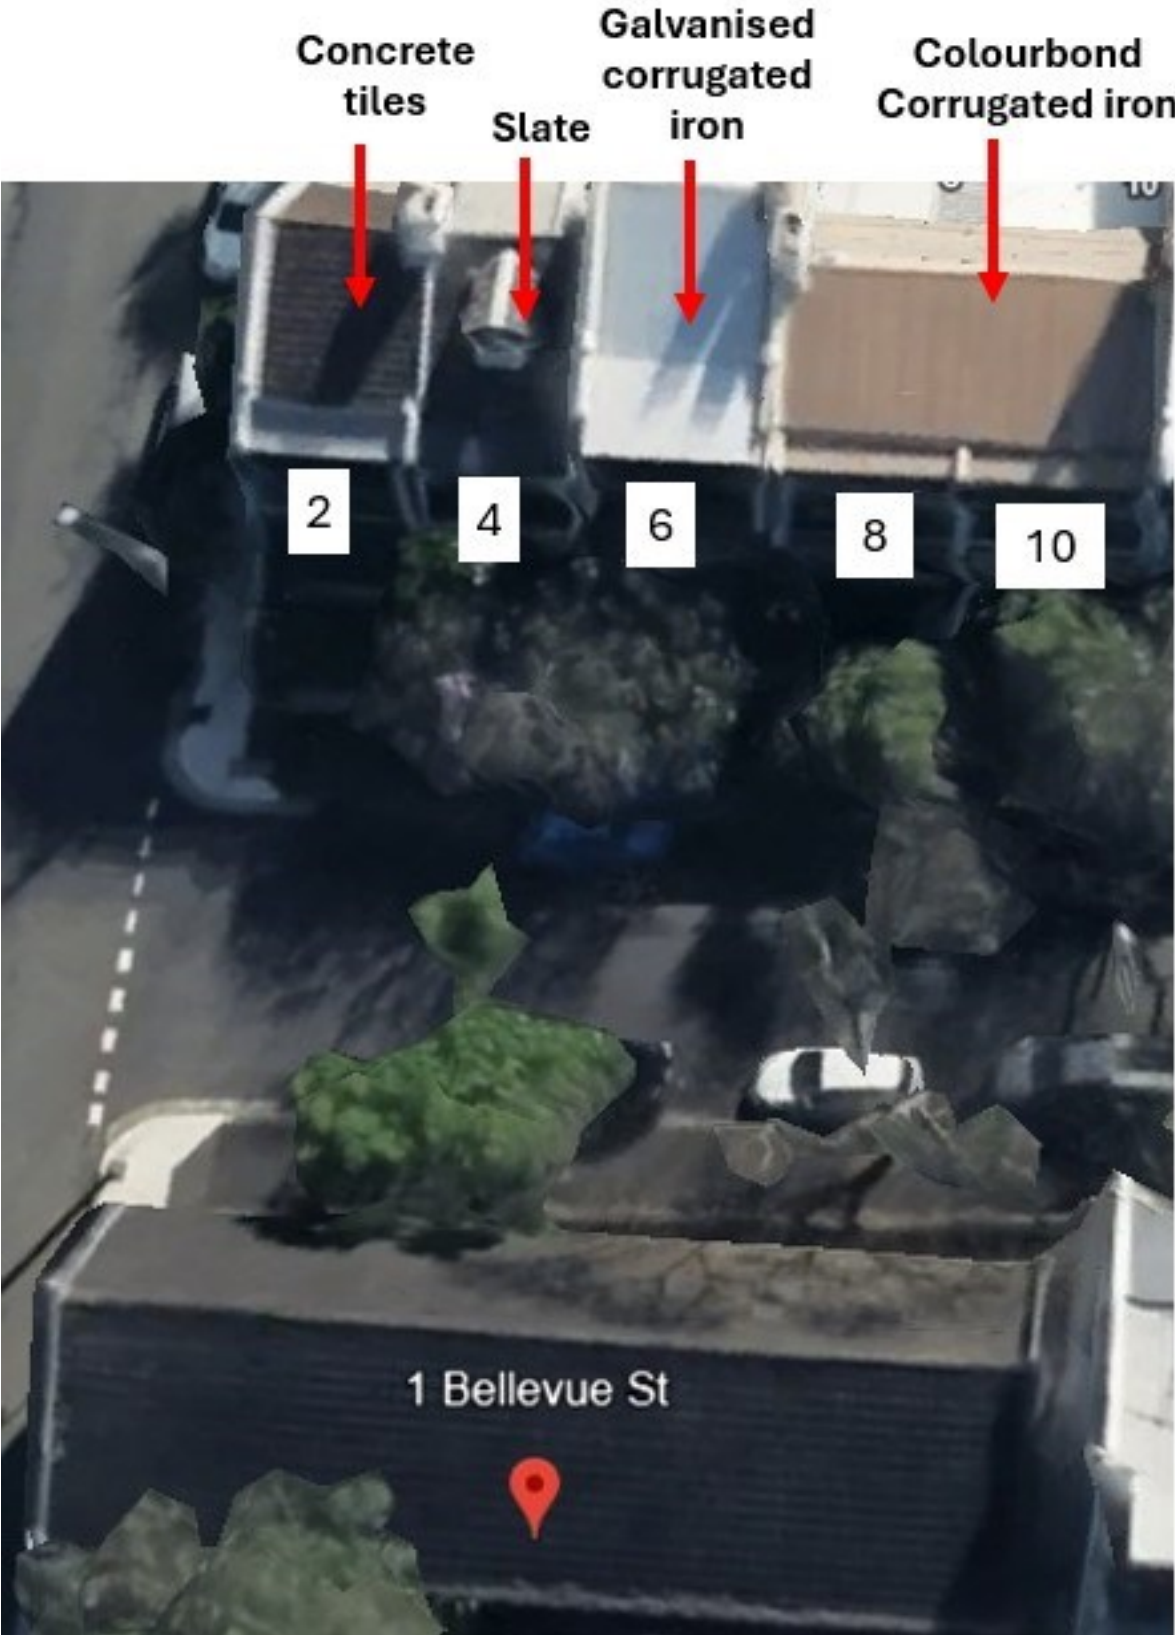
Originally the roof was slate. The concrete tiles are obtrusive. The proposal is to replace them with Colorbond standing seamed metal roofing. It is claimed that this would *be more sympathetic to the slate and corrugated metal roofs of the neighbouring properties.* It is not sympathetic and would be more obtrusive than the concrete tiles. The ideal would be to replace the concrete tiles with slate but if expense precludes this the roof should be replaced with galvanised corrugated steel roofing which is the contemporary equivalent of late 19<sup>th</sup> century galvanised corrugated iron.

Figure 1 below shows the roofing materials of the five houses facing the former St Ita's Church/School in Bellevue Street. Number four retains its original slate roof, number two (which was built as a pair with number four) has had its slate roof replaced with concrete tiles. number six is galvanised corrugated steel and numbers eight and ten are Colorbond corrugated steel. There is no seamed metal roofing here or in the neighbouring properties. Galvanised corrugated steel is preferred to Colorbond corrugated steel because it resembles a traditional material widely used in Glebe and does not fade as Colorbond roofing does. If colorbond corrugated steel is used it the colour selected should be as close as possible to the

Figure 1 A survey of the roofing materials of the houses across the road from 1 -7 Bellevue Street.

colour of galvanised corrugated steel. This would be in accordance with the recommendation in the Lyndhurst Heritage Conservation Area Inventory Report to *encourage the recovery of the original character during renovations and building upgrade.*

1. Galvanised corrugated steel be used for the roof, or Colorbond corrugated steel of a colour which is similar to that of galvanised corrugated steel roofing, rather than the proposed colour bond standing seamed metal roofing
2. The existing door at D2 , its decorative gothic revival hinges and the transom above it to be retained
3. The porch on the eastern elevation be deleted

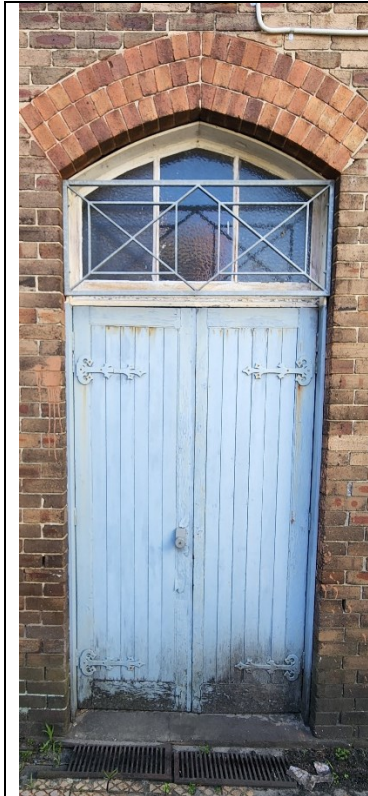
The proposal involves removing an original door with its decorative hinges and removing the original transom with its three glazing bars. This is contrary to the claim in the HIS that *no demolition of external fabric is proposed*. These elements are important and should all be retained.

Figure 2 Door D2 is an original door which retains its elaborate Gothic revival hinges. The transom window above is also original

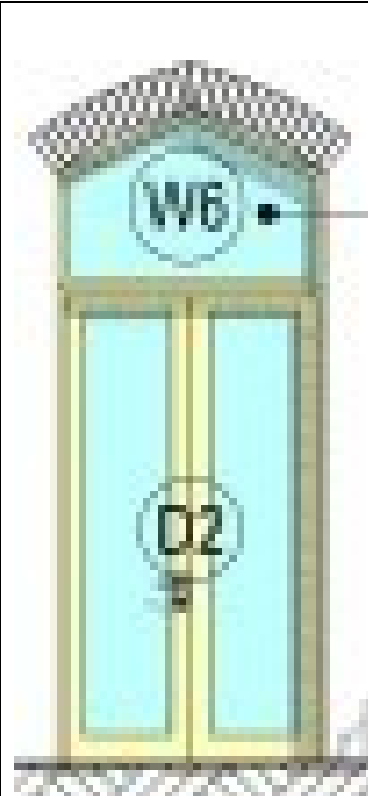
Figure 3 The proposal is to remove both the transom, the door and the hinges

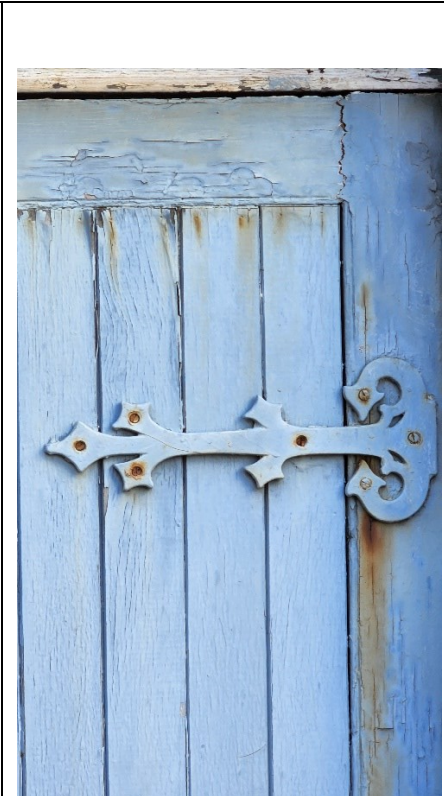
Figure 4 A detail of one of the original hinges

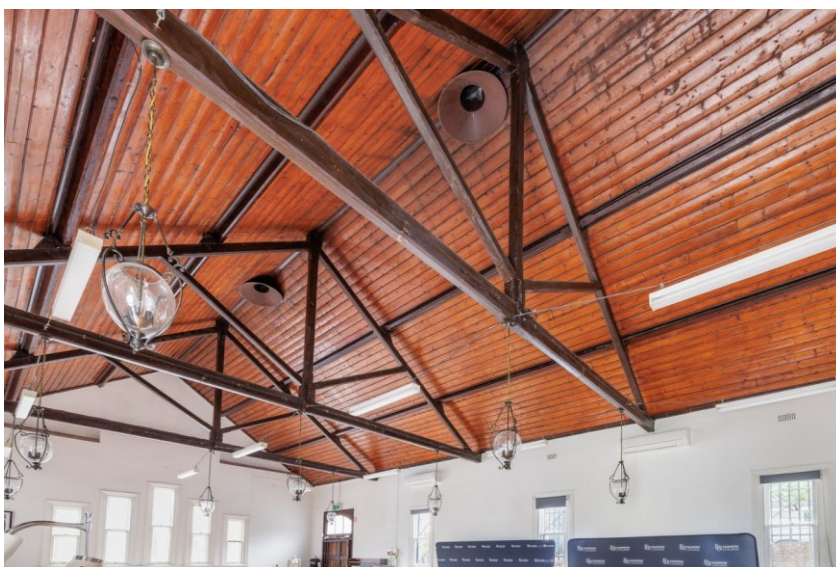
Figure 5 The original roof is very intact. The linings appear to be Baltic pine

It is important to retain the existing roof, for its materials and structure and for the original volume of the space to continue to be legible.

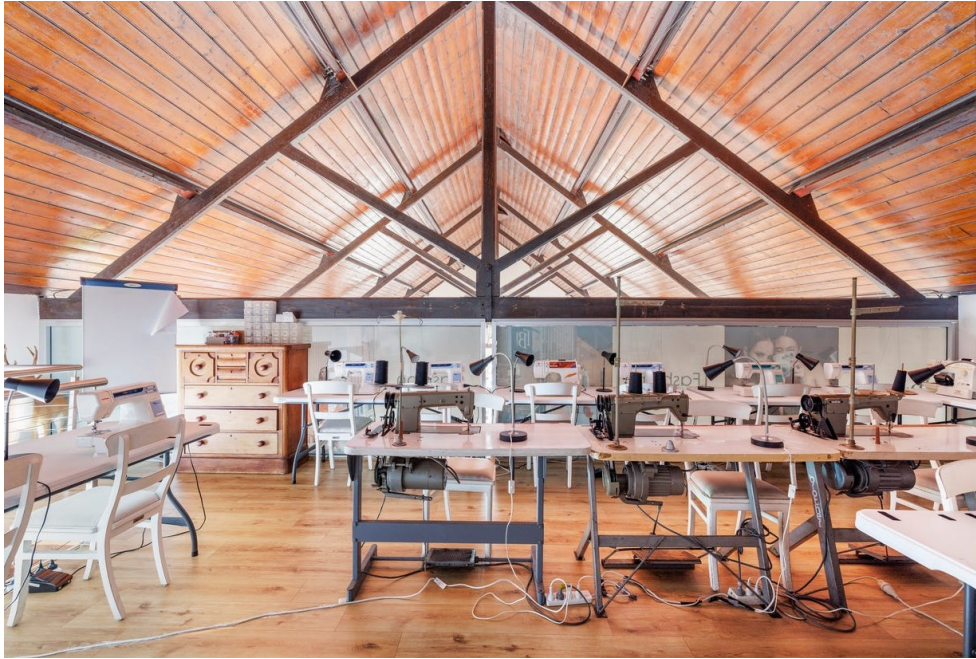
*Figure 6 The roof in the existing mezzanine*

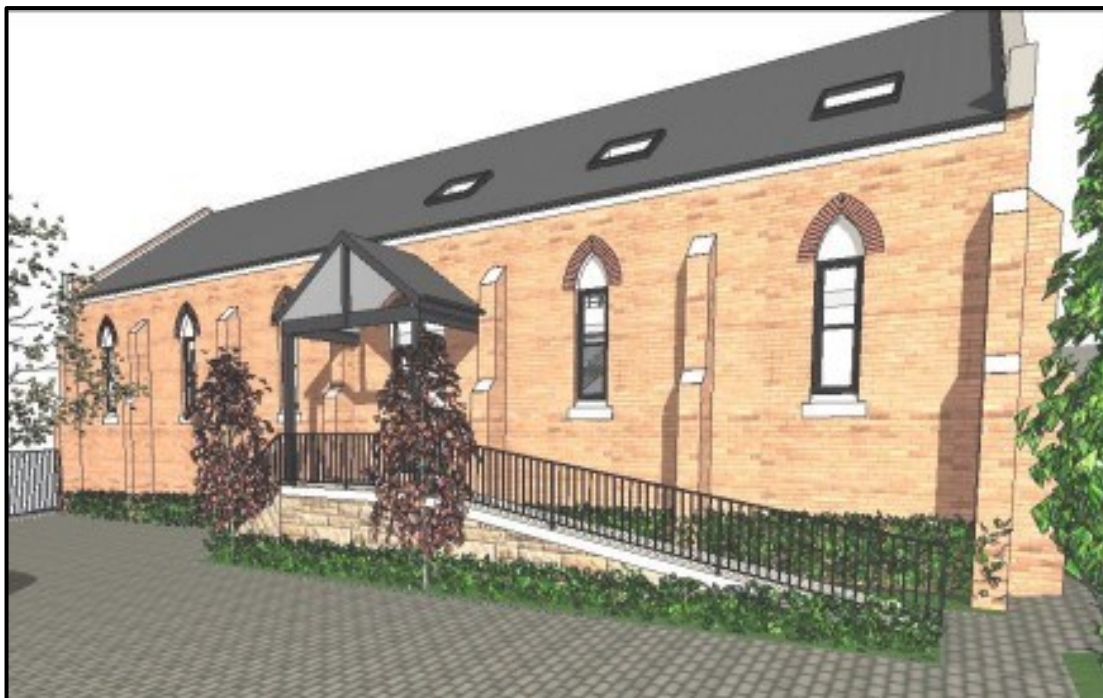
*Figure 7 The proposed porch and ramp*

The proposed porch presents as a very dominant element on the eastern façade. It also draws attention to the ramp and collectively they are very incongruous.

If the porch was deleted the ramp would be less prominent. The eastern elevation is visible from the public domain as it adjoins a park.
