Remedial Options Report

City of Sydney

12 Maxwell Road
Glebe, NSW

October 2010
JBS 41105-15450 Revision 1
JBS Environmental Pty Ltd

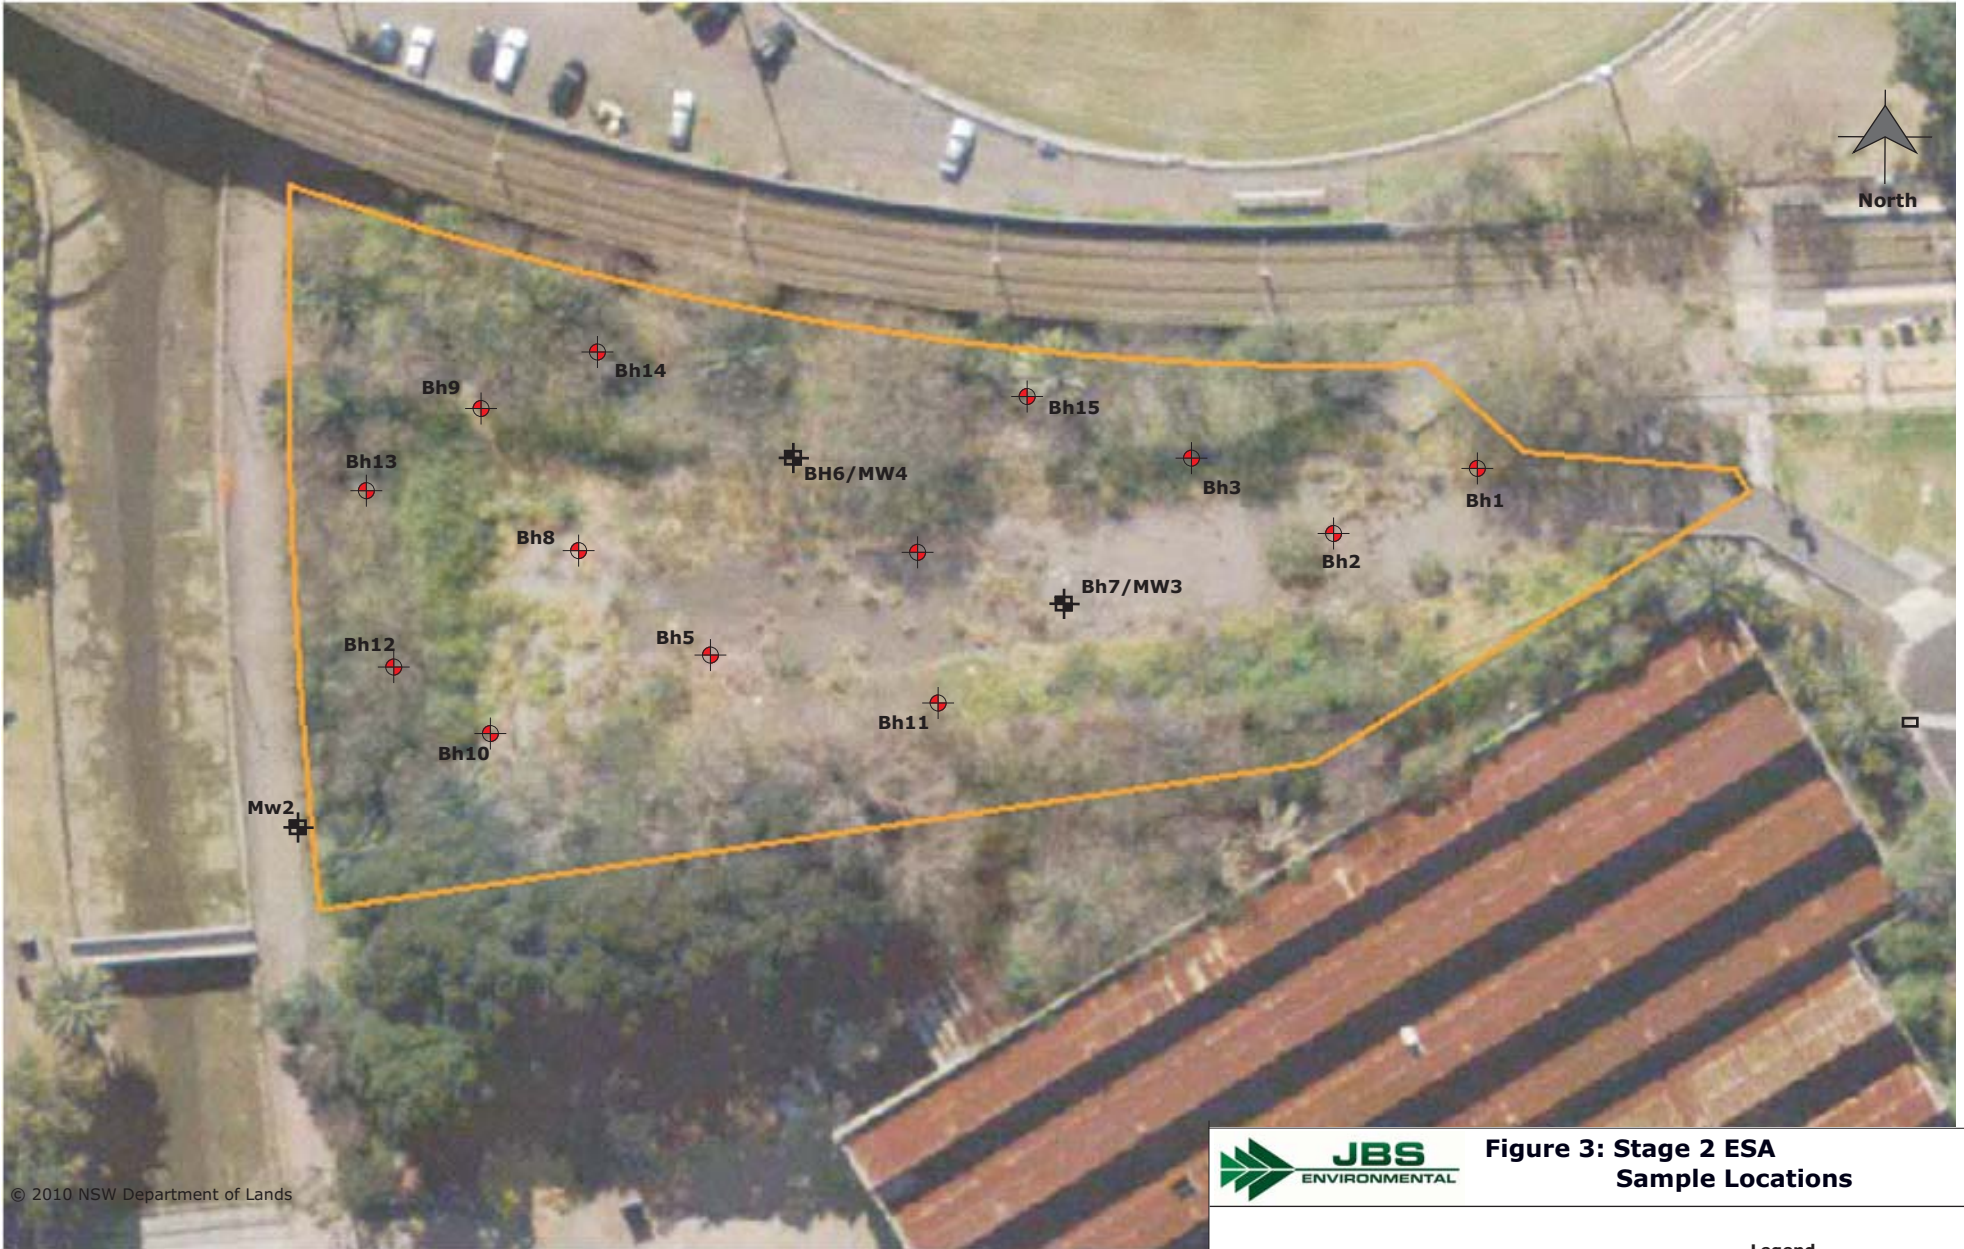
Soil sampling locations

The following sections provide a summary of the previous investigations, as listed in **Section 1.2**, positions of former test locations are presented on **Figure 3**.
